WT-1173

Operation **TEAPOT** NEVADA TEST SITE

Project 35.1
EFFECTS OF ATOMIC WEAPONS
ON ELECTRIC UTILITIES

Report to the Test Director

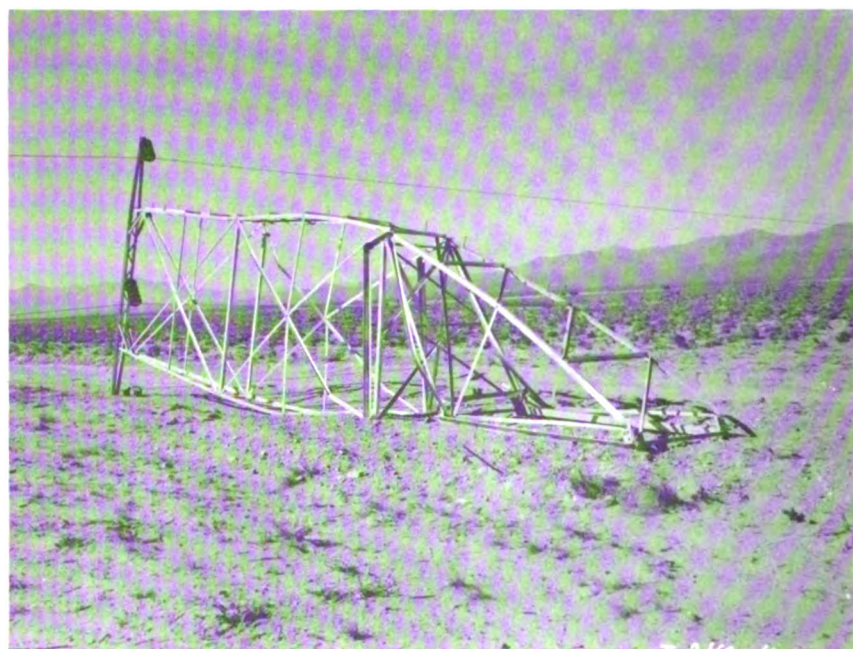
The only damage was to the suspension tower, which was blown over in a direction transverse to the transmission line (Fig. 3.4). The leg angles bent at the splice plates, which fastened them to the anchor stubs. The two leg members on the side of the tower away from the shot broke about 8 ft above the ground at a point where there were two $\frac{1}{2}$ -in. holes side by side on the 3-in. angle member. One insulator string was broken due to impact with the ground. The line conductors, splices, and hardware were undamaged.

Fig. 3.4—Structural failure of the suspension tower at the 4700-ft line.

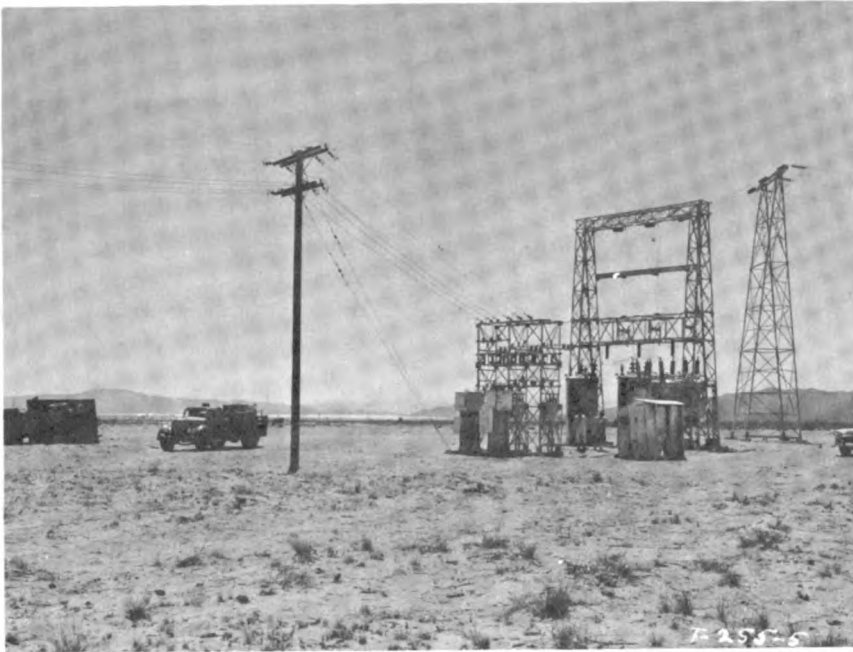
The steel dead-end structure supporting the 69-kv insulators, disconnects, and buses received minor structural damage (Fig. 3.5) in that two leg angles were slightly buckled at a point 3 ft above the foundation where several unused bolt holes were located.

Fig. 3.5—Postshot view of the substation at the 4700-ft line.

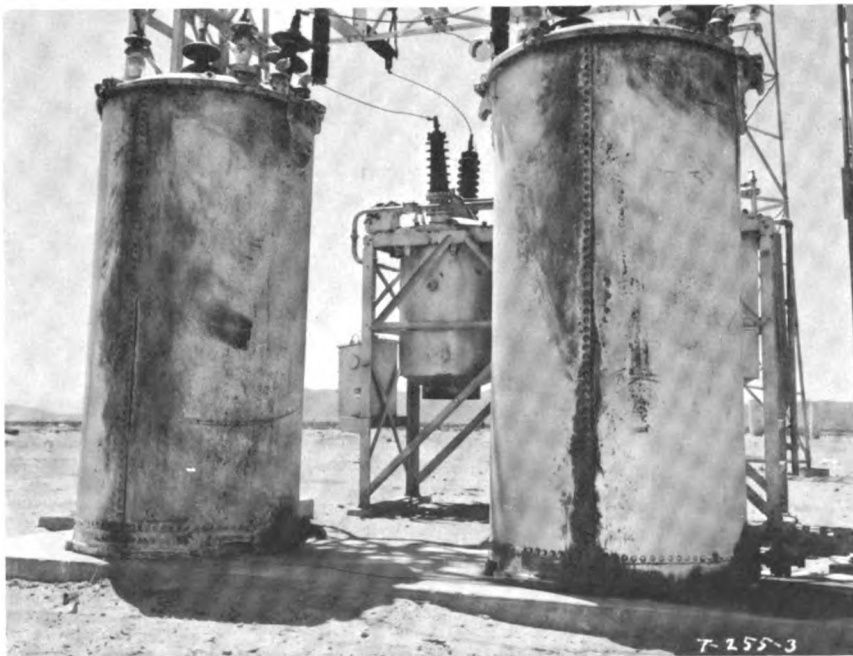
The two 1500-kva 69/11-kv transformers were undamaged and were not moved on the foundation pad. They later withstood a 30-kv a-c high-potential test to ground. The turn ratio between windings tested satisfactorily; and when meggered they gave the same values as was found in the preshot tests. The paint on the side of the case facing the blast was slightly blistered (Fig. 3.6). Neither the temperature nor the oil-level gauges were damaged.

Fig. 3.6—Thermal effect on the power transformer at the 4700-ft line.

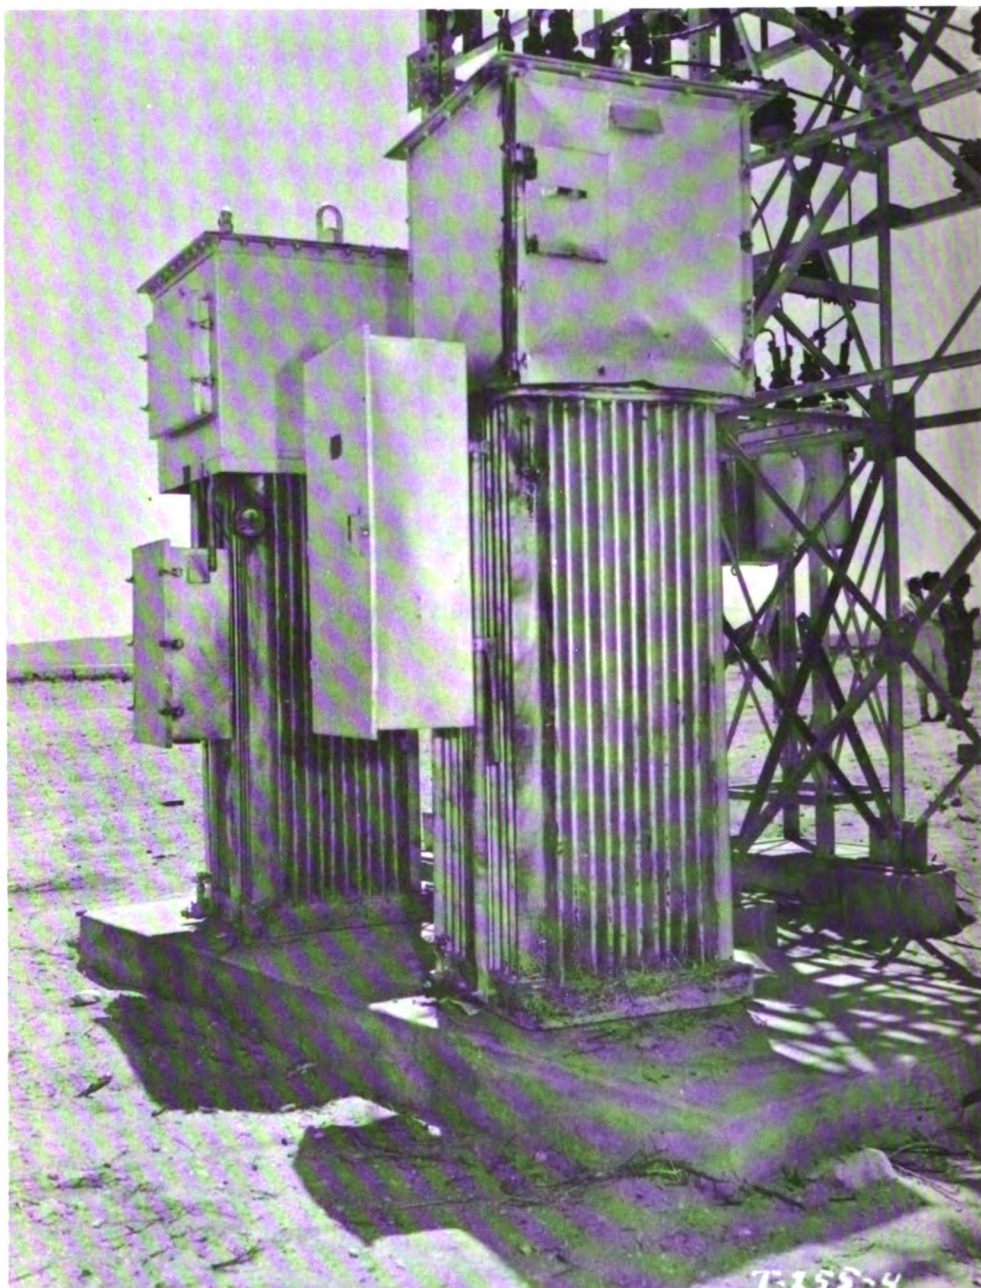
The two 4-kv 200-amp induction regulators were shifted on the foundation pad sufficiently to break electrical connections to the bus. In addition, the square flat-surfaced housing at the top of one regulator was dished on all four faces (Fig. 3.7). The flat-faced temperature-gauge glass was broken. The cylindrical oil-level gauge was not broken.

The regulators were tested and found to be electrically operative, but the raise and lower mechanism on one regulator was temporarily jammed. After approximately four operations of the raise and lower contactor, the mechanism was moving freely and was operating efficiently.

Fig. 3.7—Displacement of induction regulator and thermal effect on it at 4700 ft from GZ.

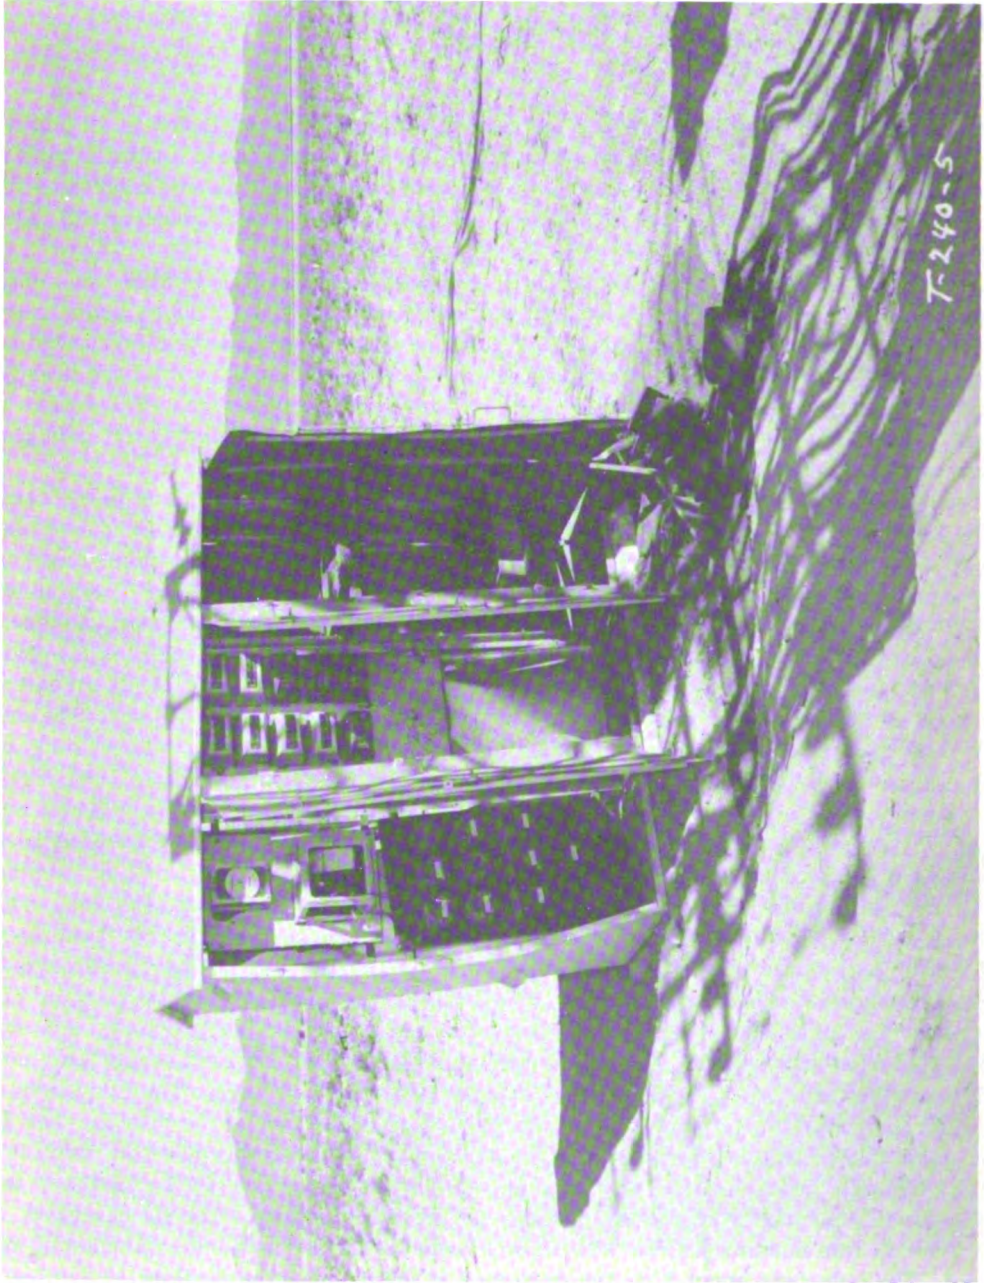
The three-compartment metal cubicle that housed meters, batteries, and instruments was severely damaged. The foundation pad to which this structure was bolted was noticeably tilted. See Fig. 3.8.

The battery cells were completely destroyed. All the glass cells were broken, acid was spilled over the ground, and most plates (both positive and negative) were damaged beyond repair.

The relays, instruments, and meters were tested identically to preshot tests and were found to be undamaged except for a broken cover glass on the recording wattmeter.

Fig. 3.8—Damage to the relay cubicle at 4700 ft from GZ.

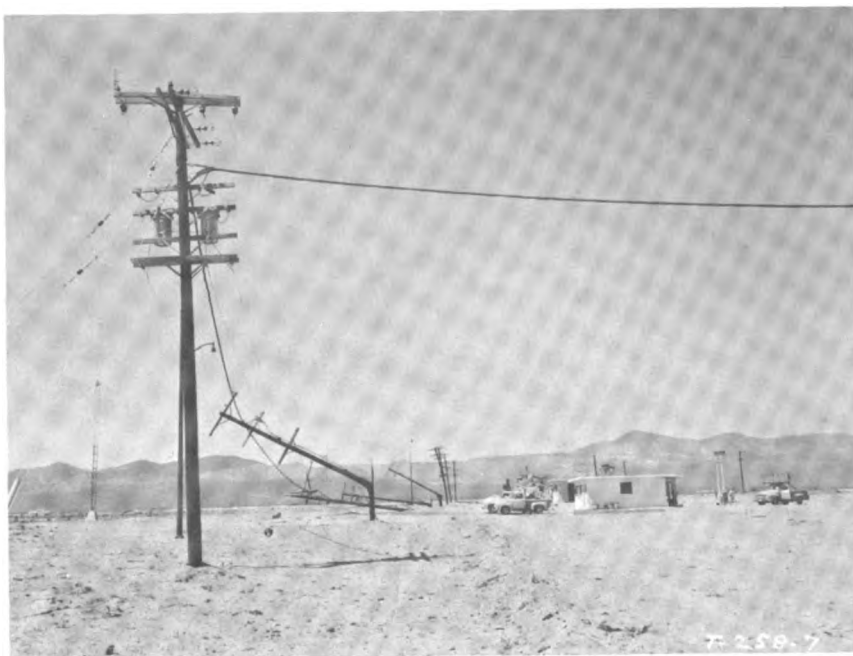
The distribution system sustained light to moderate damage. Of the poles in 14 positions, 5 were not damaged, 3 were very slightly damaged (to the extent of broken insulator pins on the 4-kv circuit only), 2 were extensively damaged, and 4 were down. No 11-kv metal insulator pins failed; and, except for down poles, the 11-kv circuit could have been reenergized. Slight scorching occurred to poles and crossarms. See Figs. 3.9 and 3.10.

Fig. 3.10—Damage to pole 12 at 4700 ft from GZ.

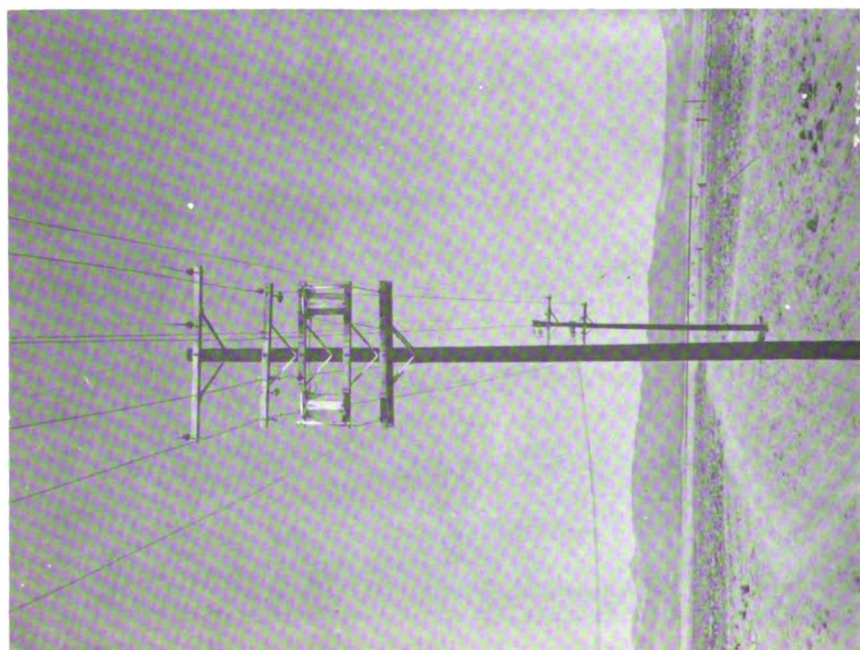
Pole 1 sustained one missing 11-kv insulator, but the pin was still in place in the crossarm. Poles 2 and 3 were undamaged. Pole 4 had two 4-kv wood insulator pins sheared and one pulled out of crossarm. The two 10-kva transformers were in place and undamaged although the crossarm on which they were hung was badly cracked. See Fig. 3.11. Pole 5 was undamaged. On pole 6 the 11-kv circuit was intact, but the 4-kv and secondary crossarms were splintered, apparently by house missiles. The 15-kva transformer was knocked to the ground at a distance of 36 ft from the pole. See Fig. 3.12. On poles 7A and 7B, the 11-kv circuit was intact, but four of the 4-kv wood insulator pins sheared, and two others pulled out. The crossarms were undamaged. The poles were displaced 4 in. at ground level and were leaning away from the blast due to the weight of adjacent down poles. See Figs. 3.13 and 3.14. The three 50-kva platform-supported transformers were blown to the ground, apparently by blast and missiles from the houses. See Fig. 3.15. The crossarms were undamaged. Pole 8 broke about 8 ft above ground level. The top portion leaned 60° from the vertical. One wood pin sheared on a 4-kv crossarm in the 4-kv circuit. The pothead was undamaged; the riser pipe bent, but the cable was undamaged. Secondaries between poles 7b and 8 snapped at the insulators on pole 8. See Fig. 3.16. Pole 9 broke at ground level, but the 11-kv circuit was intact. No damage was noted to the crossarms, capacitors, or insulators. The aerial cable was unbroken from pole 9 to pole 14. See Fig. 3.17. Pole 10 broke 1 ft below ground level. A 15-kva transformer was knocked to the ground and broken. The top of pole was split. The 11-kv crossarm was not broken but was separated from the pole. One 11-kv insulator was broken. The crossarm supporting the aerial cable was separated from the pole but was held on by the braces. One 11-kv conductor (#2/0 ACSR) was frayed and cut in half by the radio-tower guy wire on which it fell. See Figs. 3.18 and 3.19. Pole 11 was broken 8 ft above the ground. One 11-kv insulator was broken. The riser pipe was bent, but the pothead and the aerial cable were not damaged. See Fig. 3.20. Pole 12 was undamaged; the two 10-kva transformers remained in place and were not damaged. The pole bent about 5° in the direction of the downed poles. Pole 13 had one 11-kv insulator missing. The mast arm of the luminare was deflected about 10°. The globes, which were elliptically shaped, were not broken. Pole 14 was not damaged. The mast arm of the luminare was deflected about 10°, but the elliptical globes were not broken.

Fig. 3.11—Damage to pole 4 at the 4700-ft line.

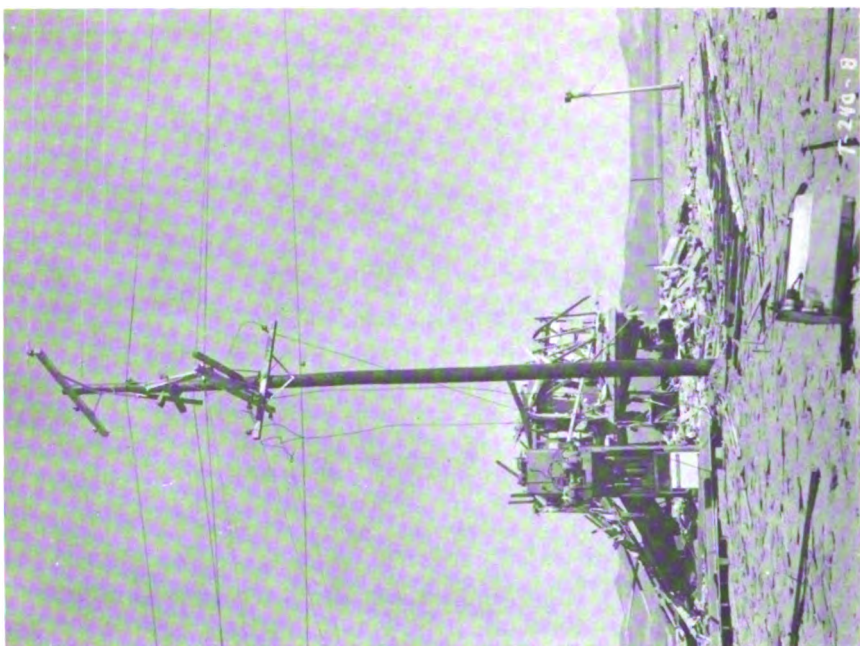
Fig. 3.12—Damage to pole 6 and transformer at the 4700-ft line.

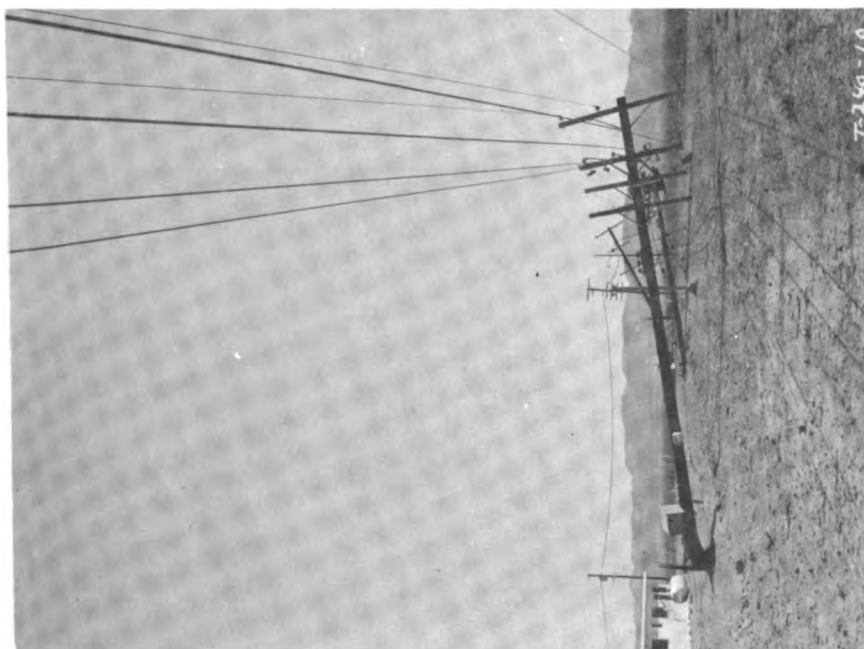
Fig. 3.14—Damage to distribution poles at the 4700-ft line.

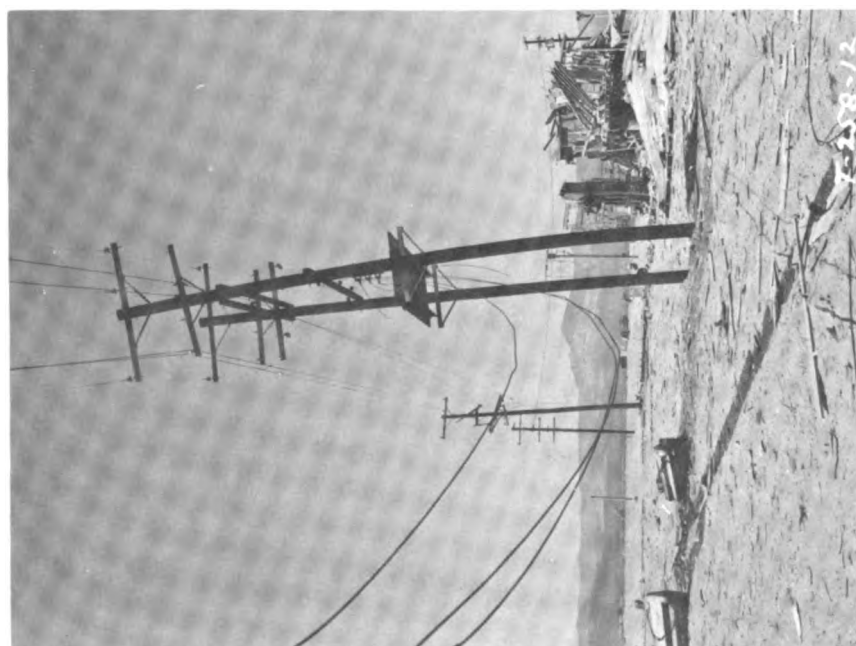
Fig. 3.13—Damage to poles 7-A and 7-B at the 4700-ft line.

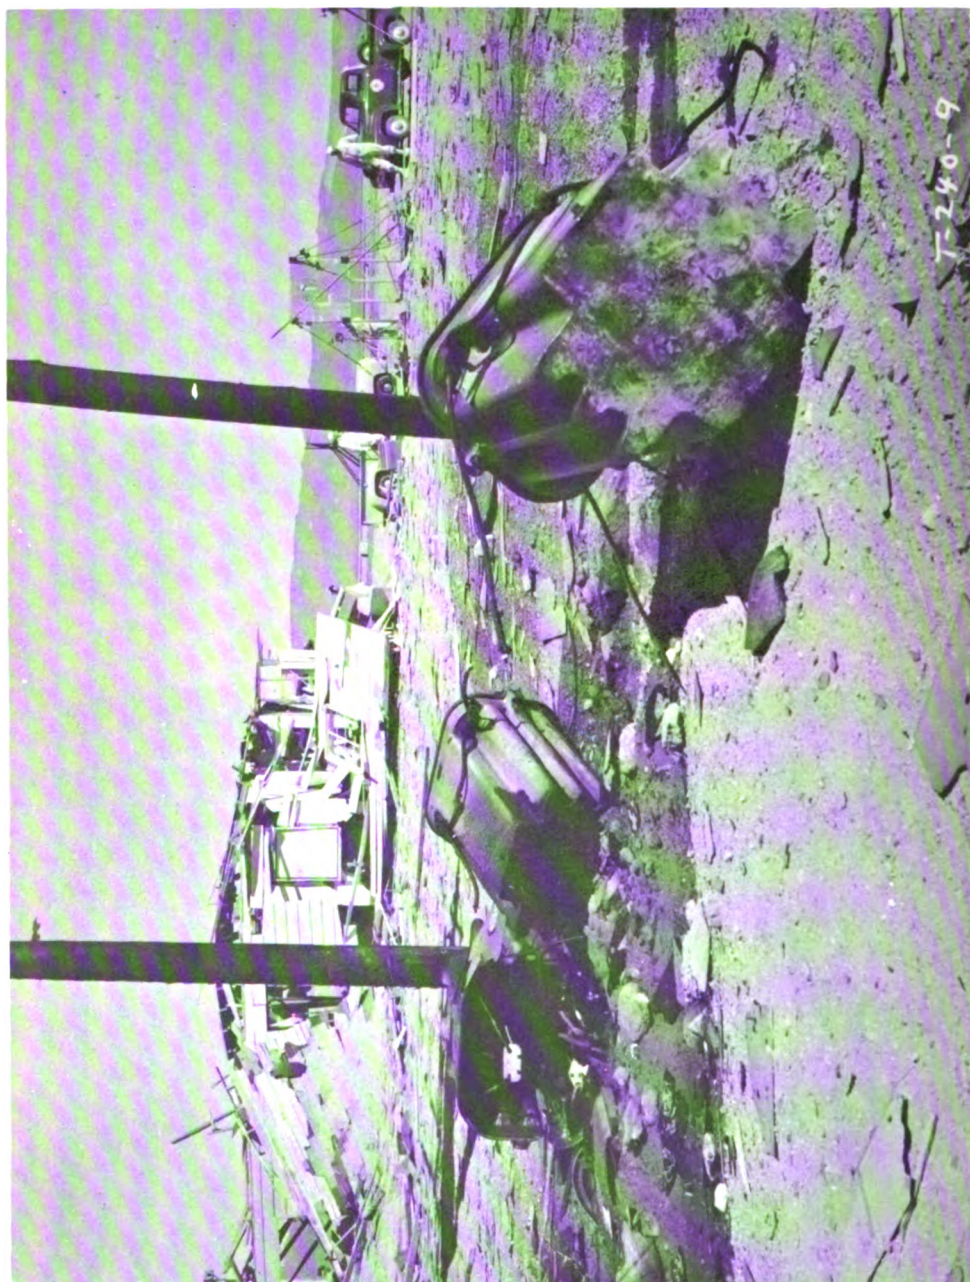
Fig. 3.15—Damage to transformers mounted on platforms at the 4700-ft line.

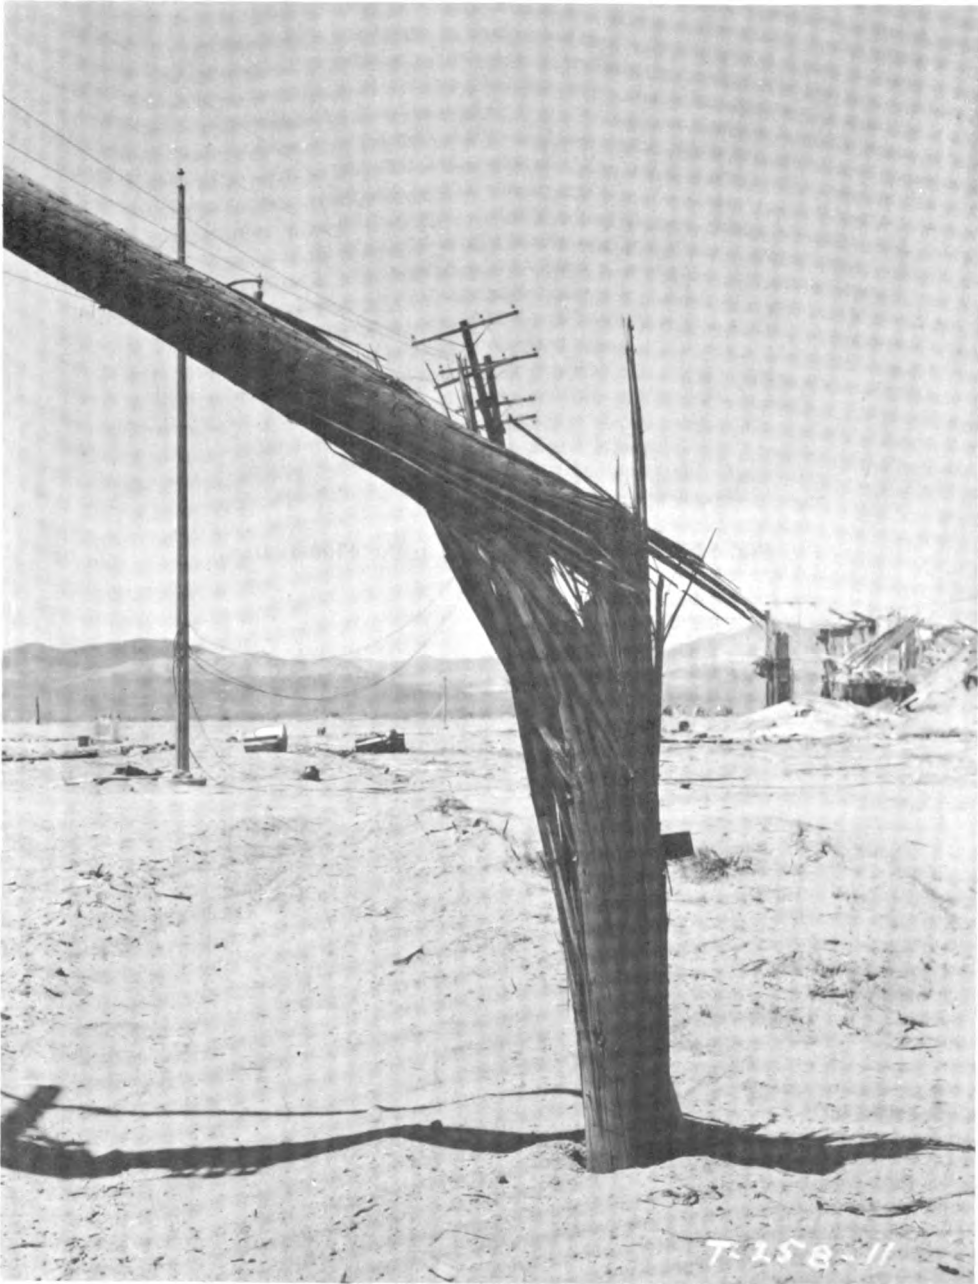
Fig. 3.16—Damage to pole 8 at the 4700-ft line.

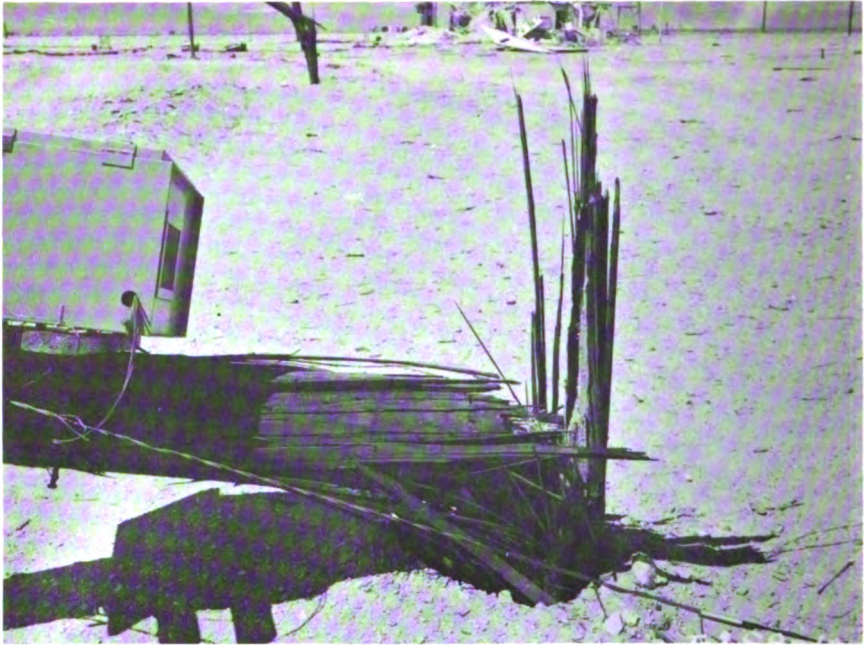
Fig. 3.17—Damage to pole 9 at the 4700-ft line.

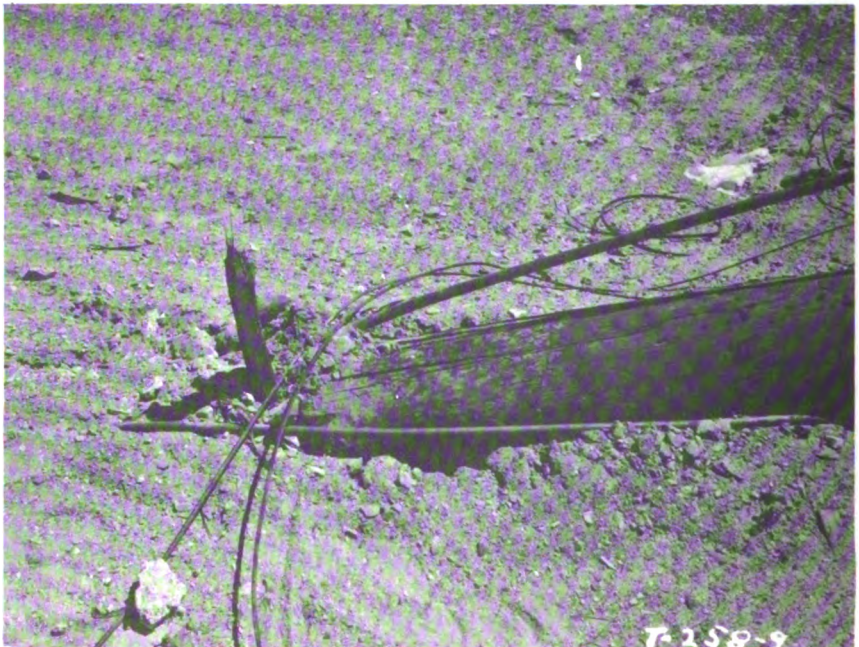
Fig. 3.18—Damage to pole 10 at the 4700-ft line.

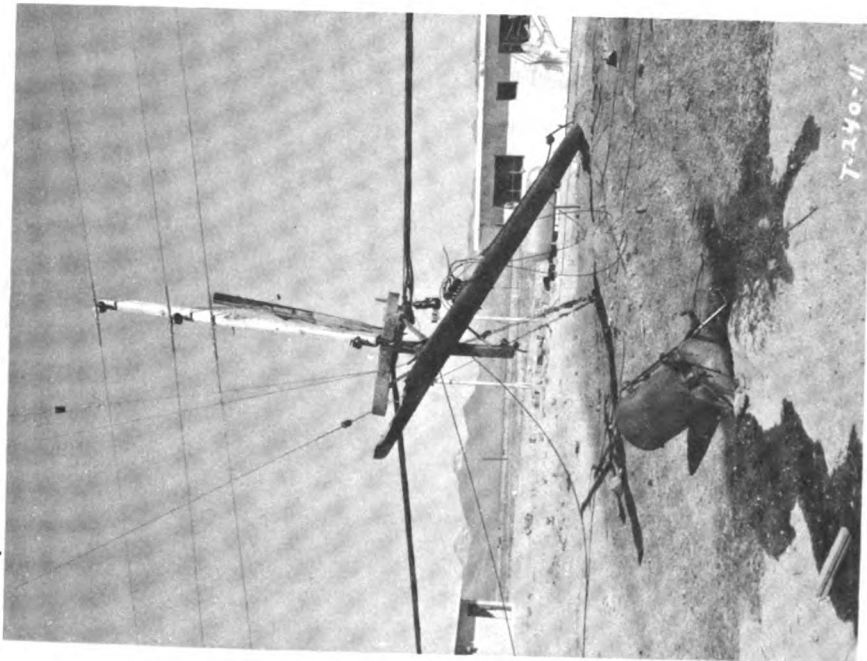
Fig. 3.19—Damage to transformer at the 4700-ft line.

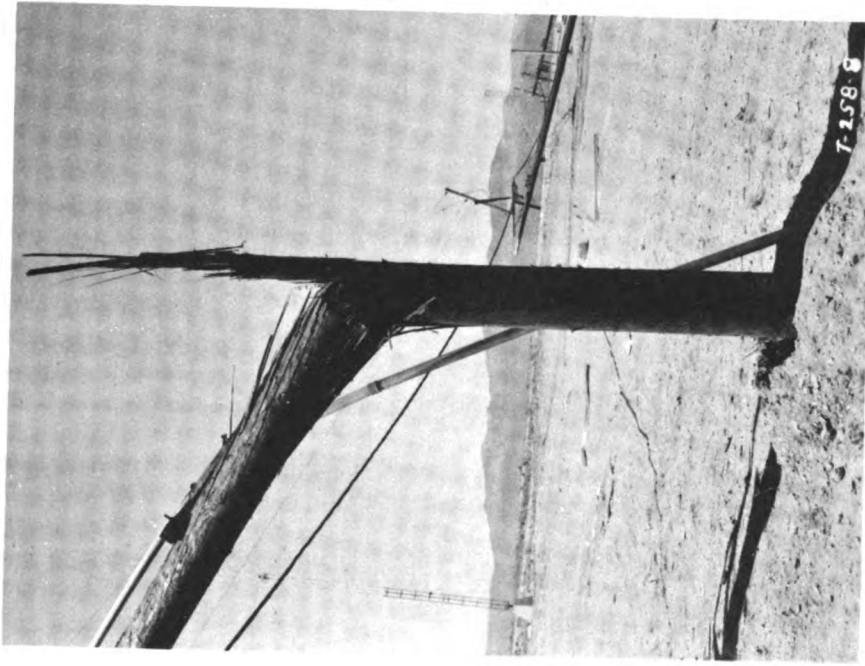
Fig. 3.20—Damage to pole 11 at the 4700-ft line.

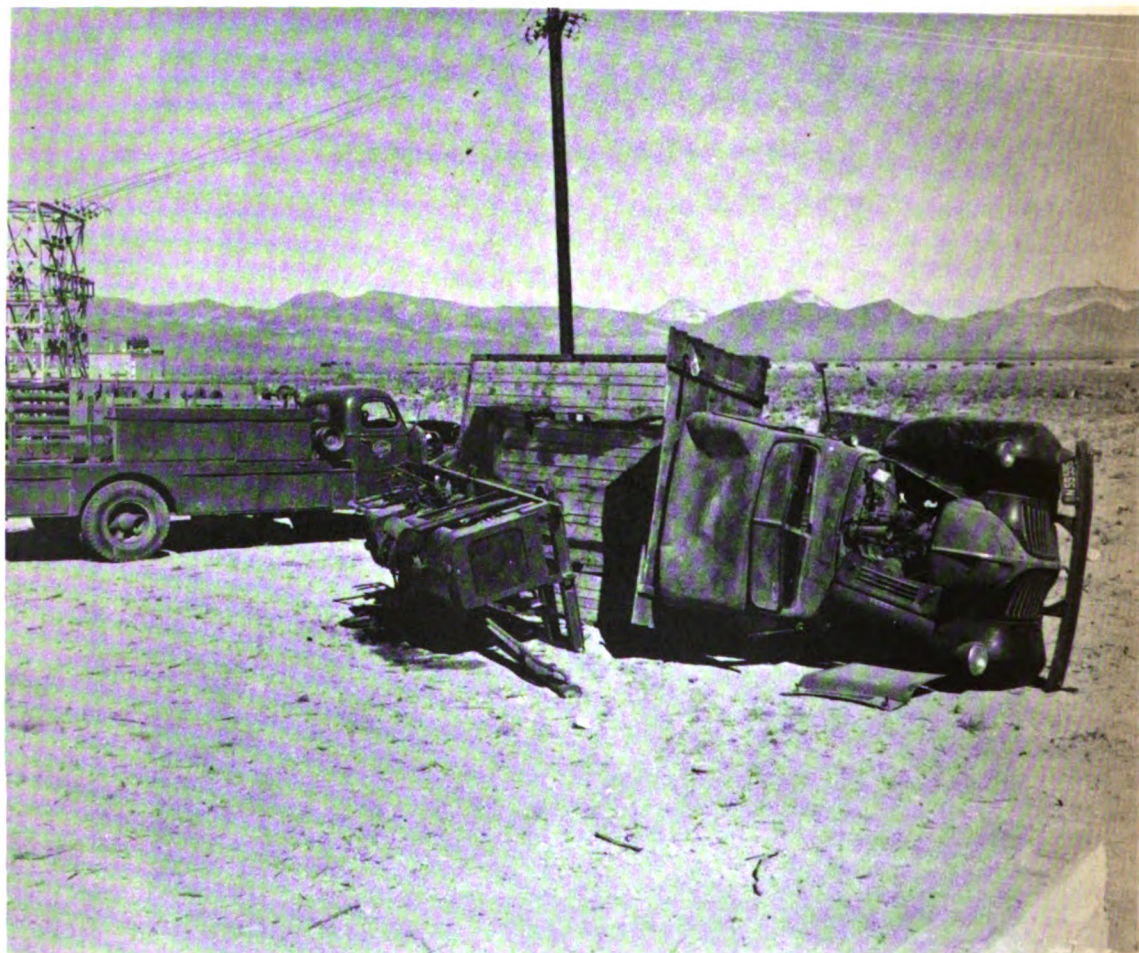
The heavy crew truck, exposed in Project 36.2, sustained broken windows and a bent hood, but its equipment was not damaged.

The truck that was equipped with an earthboring machine (also exposed in Project 36.2) tipped over, sliding the boring machine to the ground (Fig. 3.21).

Fig. 3.21 — Damage to service vehicles at the 4700-ft line.
